Washington State DOT 8-Year Corrosion Study

Report from on the Washington State DOT

8 year Corrosion Study

During the week of the 8th of May, PRP Industries visited the Washington State DOT (WS DOT) facilities in Yakima and Pasco to inspect the three trucks involved in the WS DOT long-term Corrosion study.

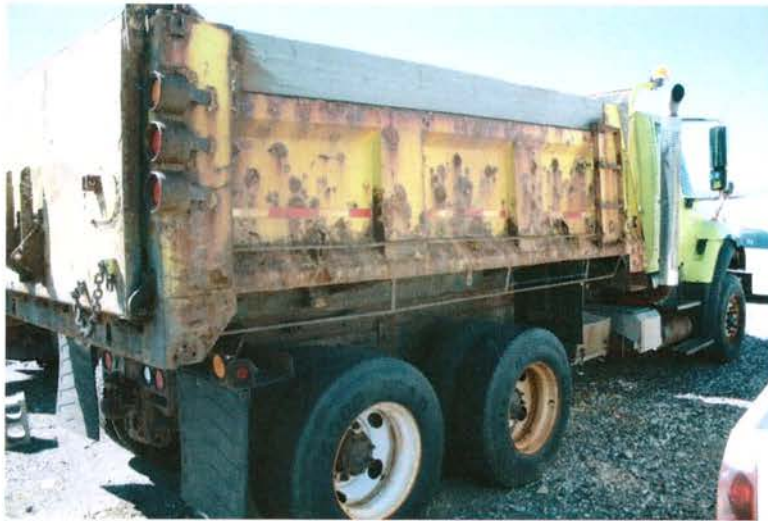
Truck 33 parked in the disposal yard at Yakima.

WS DOT operational plan calls for a life of 15 years for these vehicles. Truck 33 in its eighth year had already been placed on the disposal list and was being offered for sale.

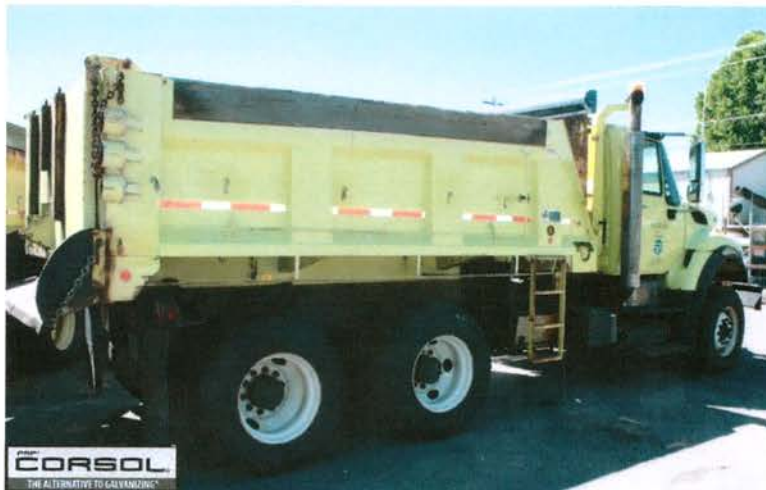
Truck 34 at the Pascoe facility.

The WS DOT had conducted this trial independently of any of the suppliers. The desire was to achieve actionable conclusions from the testing. The results from the testing seem obvious truck 34's condition would indicate that it will achieve the 15 years of operational life that the WS DOT is seeking and should still retain a good resale value at the time of disposal.

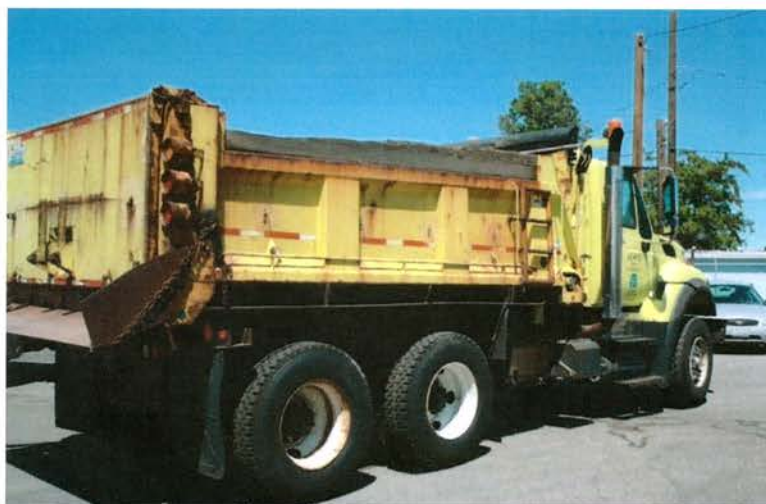
Truck 35 at the Pascoe facility.

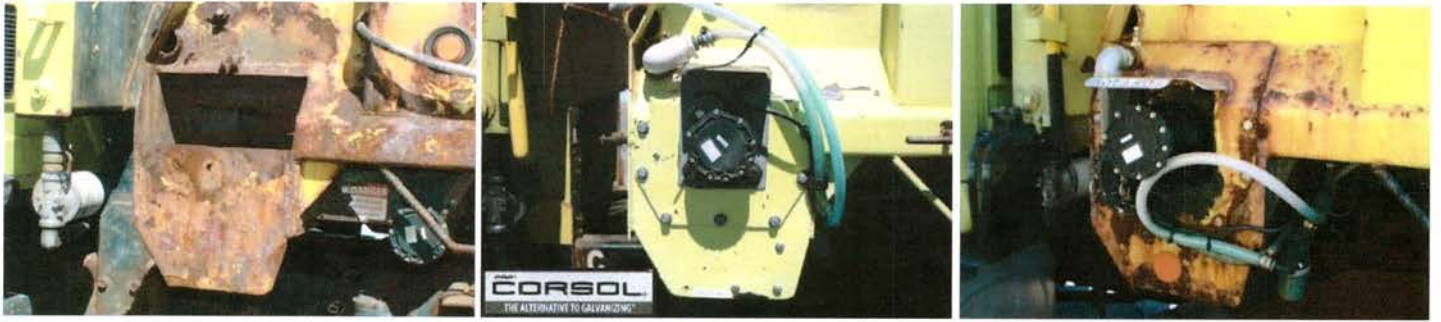
Close-up of the chloride wetting system on trucks 33, 34 and 35.

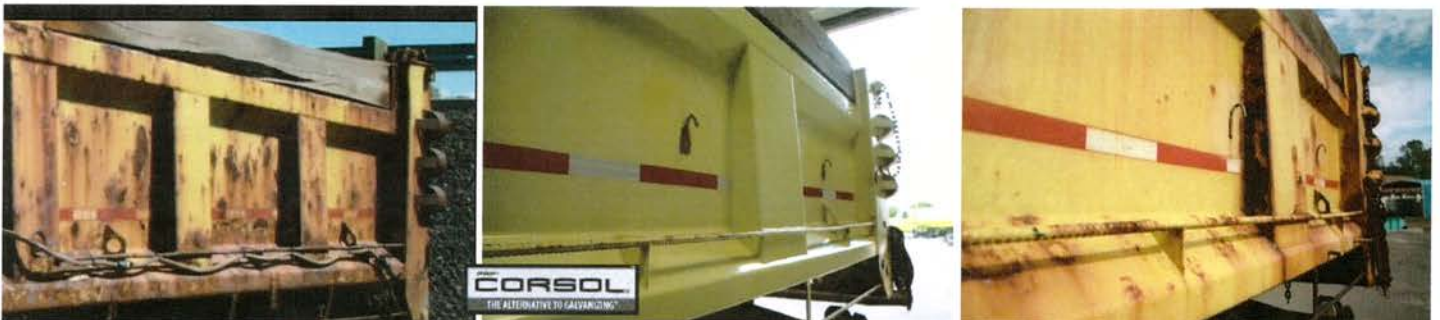
Close-up of the driver's side of trucks 33, 34 and 35.

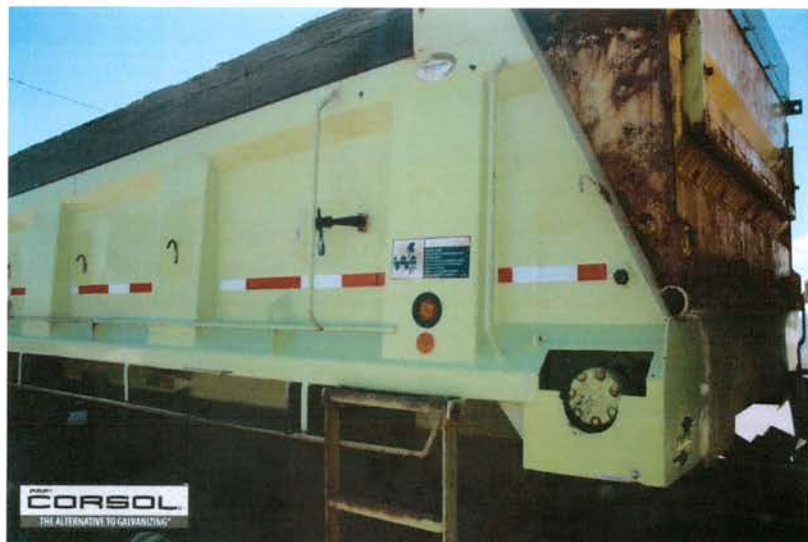
Unit 34. The front gate and the ladder were painted utilizing the WS DOT standard paint system

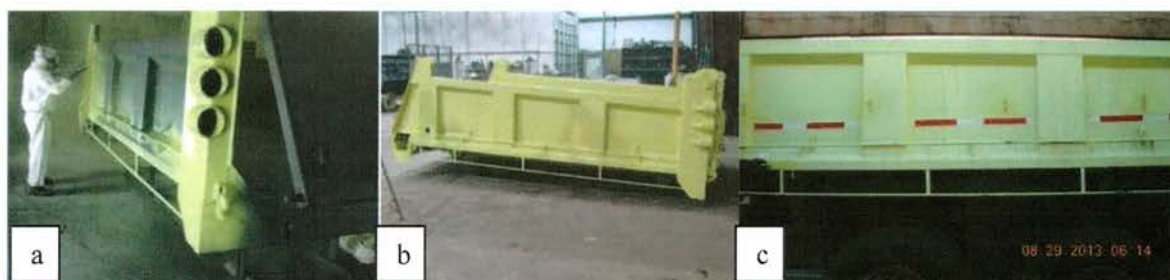
Figure 55. a & b) A new body treated with PRP CORSOL, then top coated with PRP Acrylic Urethane, c) a dump body after 5 years of use on a salt spreader truck (WSDOT & PRP, 2014).

PRP Industries entered into a corrosion test study with WSDOT. PRP Industries will perform a series of field studies using WSDOT plow trucks to identify cost effective solutions to corrosion problems on these vehicles (WSDOT & PRP, 2014). This study will help to identify solutions to corrosion on vehicle frames, fuel tanks, wheels, air valves, dump bodies and various other components. The test will be conducted on new trucks and components going into service and examples are shown in Figure 55, Figure 56, and Figure 57. The two trucks went into service December 2008.

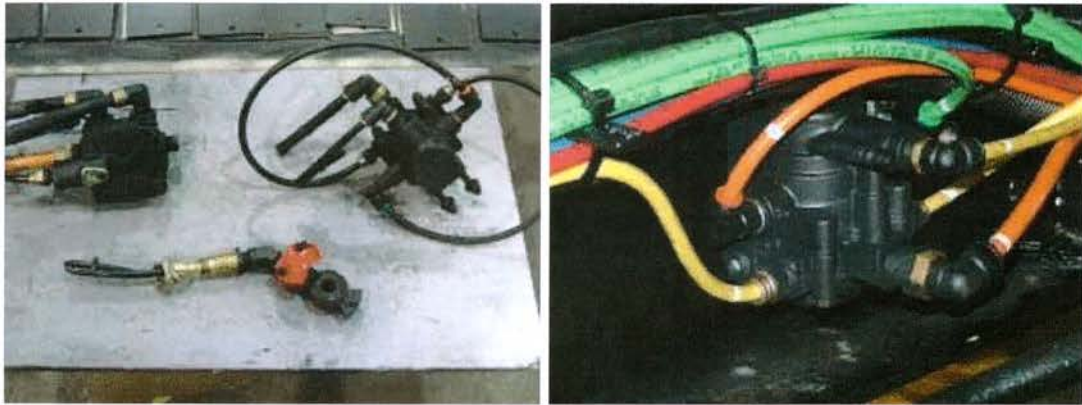
Figure 56. Brake valves and glad hand treated with CORSOL prior to installation (WSDOT & PRP, 2014).

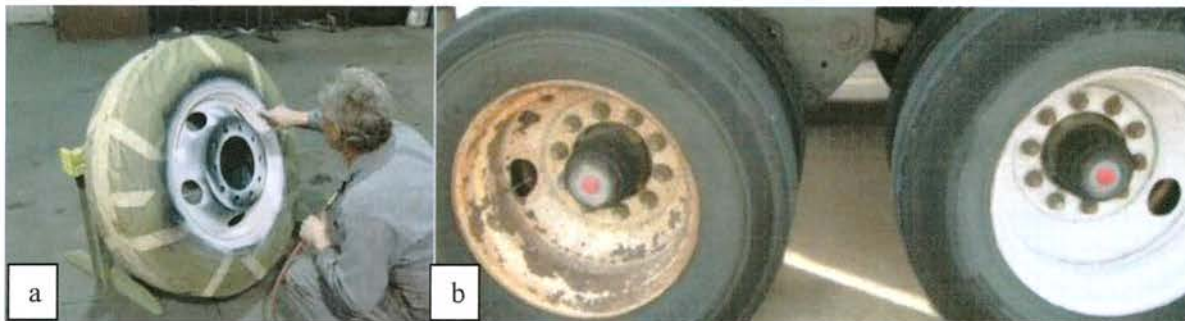
Figure 57. a) A new wheel is stripped of its coating, treated with CORSOL, then top coated with PRP Hybrid Urethane, b) trailer wheels after 6 years (left) and in field success of COROSOL after 6 years (right) (Courtesy of PRP industries; WSDOT & PRP, 2014).

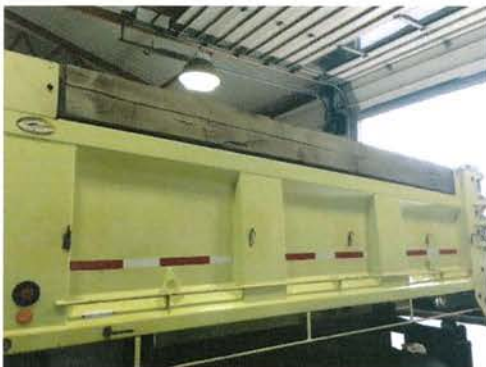
Truck 34

Updated photos supplied by WDOT from 2016 of the Trucks 34 with the CORSOL® corrosion solution and 35 standard automotive paint system.

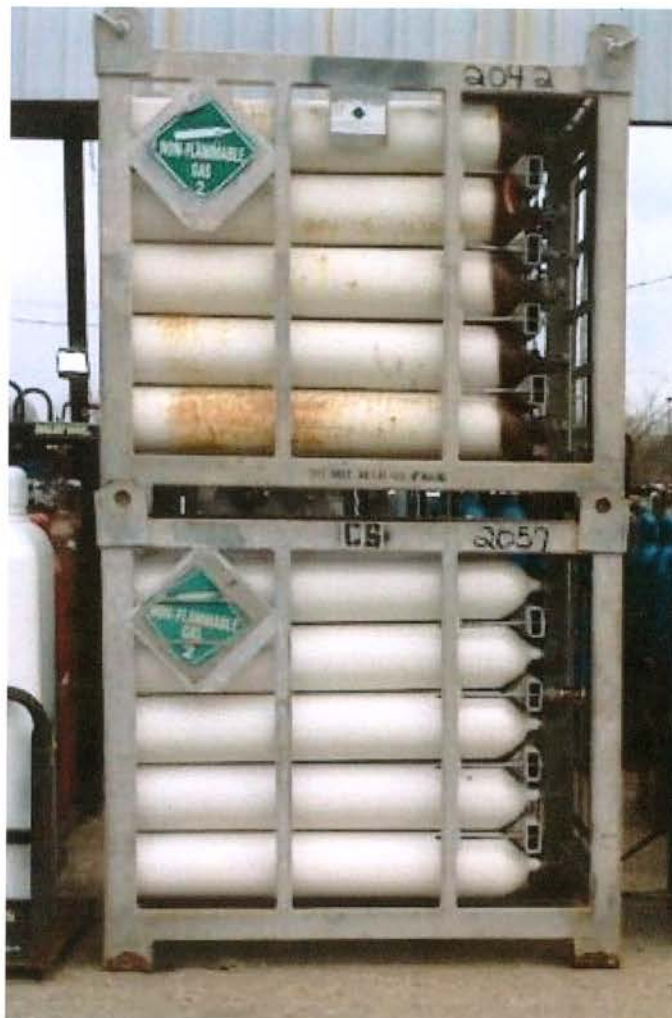
Gas cylinders that were being sent offshore were corroding within a year. The corrosion caused pitting of the steel, which reduced the service life of the gas cylinders. A Corsol Metal Treatment System was applied to mitigate the corrosion problem (Figure 60). This same treatment technique has been used to successfully protect the fuel tanks (PRP, 2014).

Figure 60. The standard cylinder group on top compared to the PRP treated cylinders on the bottom (PRP, 2014).
